# The Stations of the Tyne Valley Line

A review of the buildings, facilities and environment at the stations on the Tyne Valley Line, carried out on behalf of the Tyne Valley Community Rail Partnership (TVCRP)

October 2022

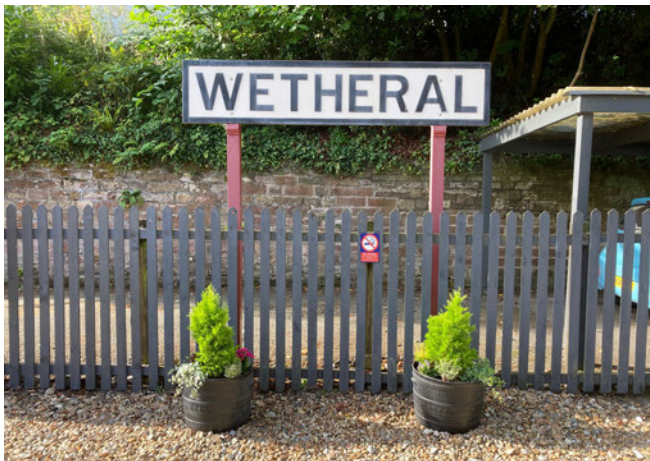
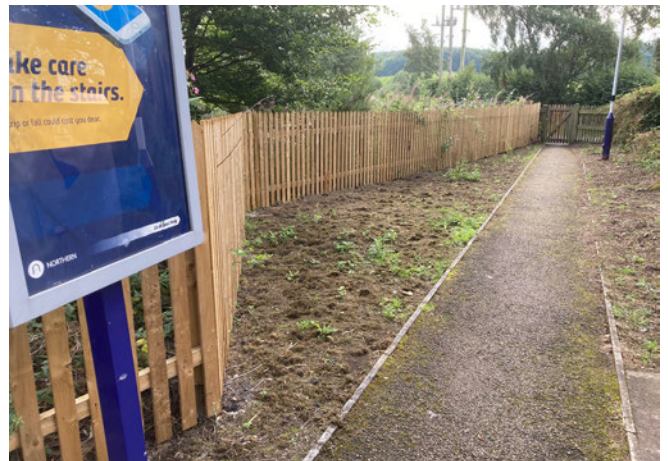
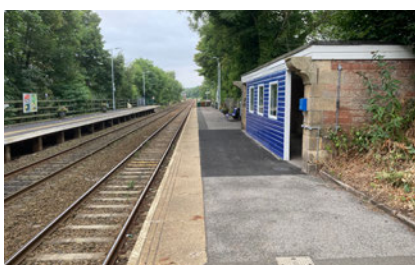
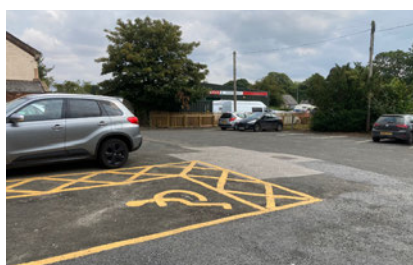
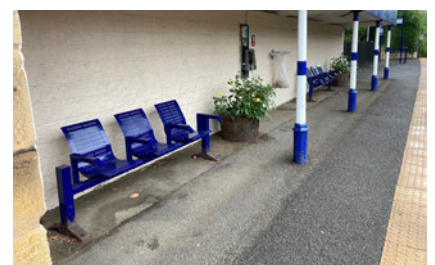
1. The trees between the platforms and adjacent housing at Dunston have been trimmed back which improves the visibility of the platforms and may provide a degree of passive supervision of the station.

2. Redundant cycle lockers have been removed generally.
3. New seats have been provided at several stations including Riding Mill, Stocksfield and Haltwhistle.

4. The car parking at Haydon Bridge has been re-lined.
5. New planters have been provided at several stations.
6. The shelter on platform 1 at Bardon Mill has seen improvements by the addition of windows, removal of the area of ponding, new road surfacing and fencing on the approach to the station and the replacement of the lifting floor surface on platform 2.

7. Stonework to the station entrance at Hexham has been repaired.
8. New fencing to the entrance to platform 2 at Brampton.
9. Fencing has been repainted at Wetheral and Wylam etc.

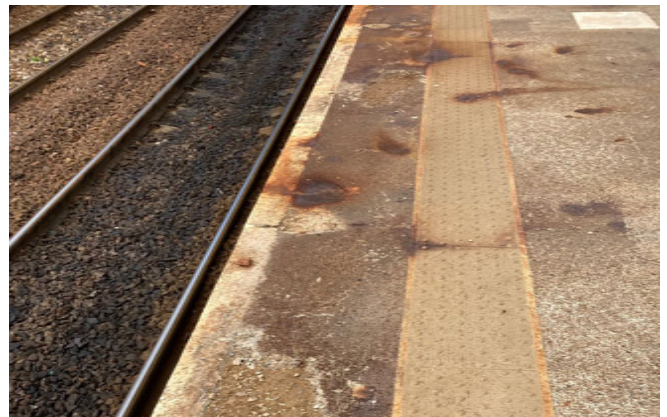
Potential trip hazards on Platform 1 at the Metrocentre and on the footbridge at Blaydon were reported on 27th July 2022. It is disappointing to note that the Blaydon fault was reported in the 2021 review and no action has been taken.

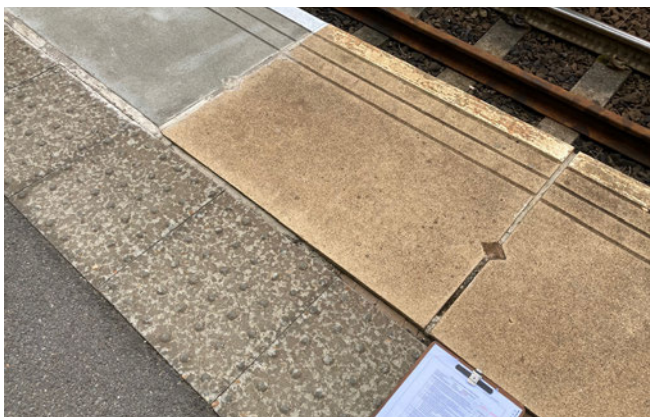
There is a lip between the tactile paving and the edge units on platform 1 at Wylam which may be considered to be a trip hazard and should be inspected as soon as possible.

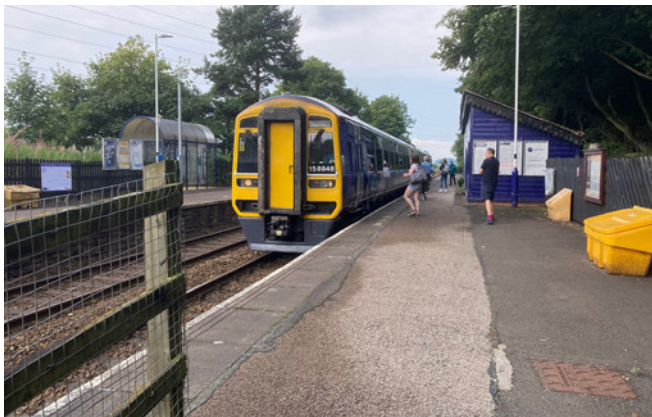
There are no tactile pavings on platform 1 at Bardon Mill and on both platforms at Brampton. It is disappointing to note that these were included in the 2021 Station Reviews.

Lack of tactile paving

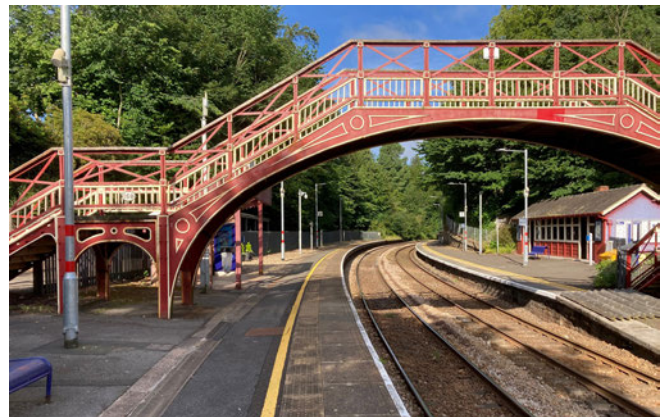
The yellow lines on the inner edges of tactile pavings, which are there to warn the partially sighted that they are approaching the platform edge are only in place at the mainline stations and at Wetheral.

Yellow line

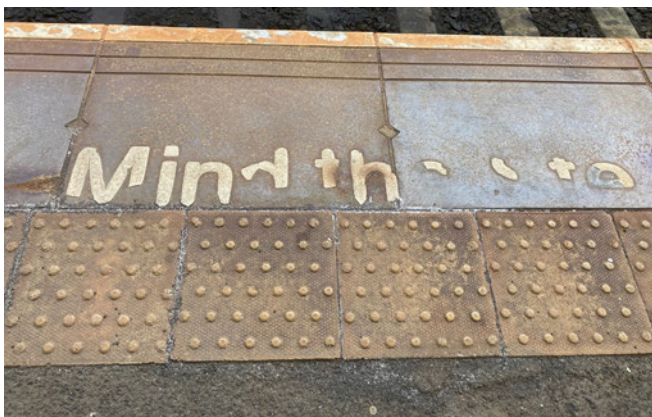
The white lines to the platform edges have faded badly over time and could be usefully repainted at all stations.

White line

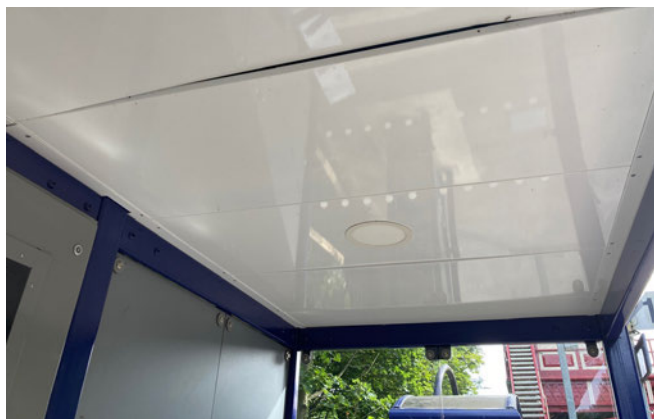
It is good to report that there is very little evidence of vandalism to the stations with virtually no graffiti. The damage to the ceiling of the platform 1 shelter at Wylam was the only notable item.

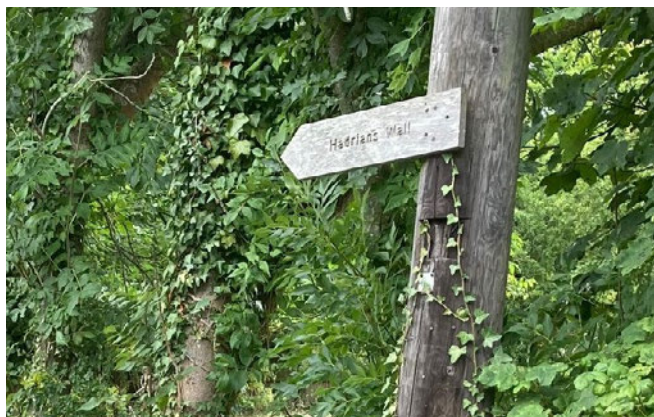
Bardon Mill

Signage in and around stations could be vastly improved, particularly with regard to signage to local points of interest and tourist destinations. A case in point is Bardon Mill, which is the station closest to Hadrian's Wall and the various attractions which form part of the World Heritage Site - and there is no adequate signage for the visitor.

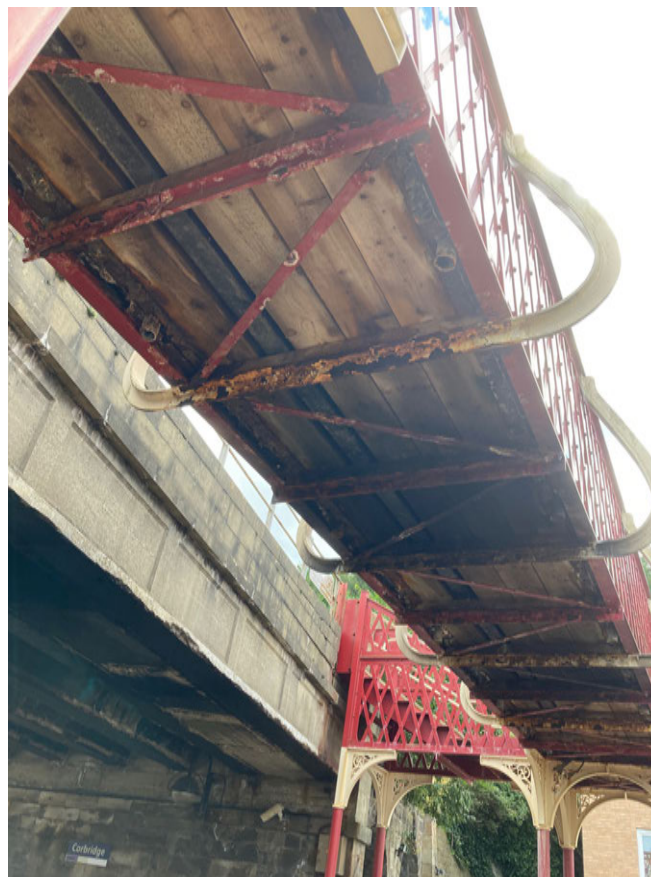
Many of the footbridges along the line are showing signs of corrosion to the steel structures. Corbridge appears to be in the worst condition but it is followed closely by the bridges at Wylam, Bampton, Hexham and Blaydon. The ramp access structure at Dunston is equally in need of treatment.

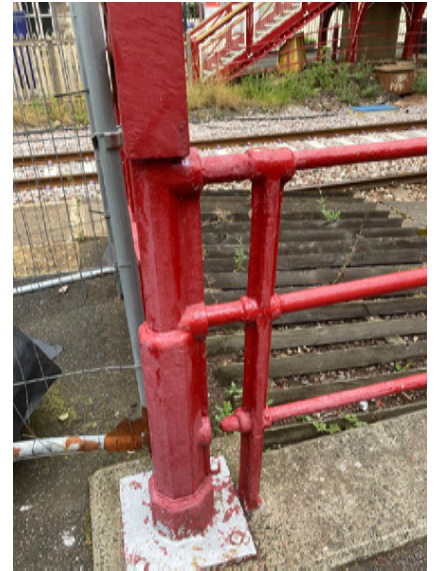
1. As mentioned in section 3.5 of this report, the steelwork to the footbridges is severely corroding. There should be a rolling programme of regular maintenance to these structures including the paintwork. It should be noted that the footbridge at Haltwhistle which has recently been re-painted is already showing signs of deterioration. Patches of paint are loosing their gloss and starting to exhibit a chalky appearance. The varnish on the hardwood handrail is also starting to flake off. This is also prevalent along the line e.g.Stocksfield.

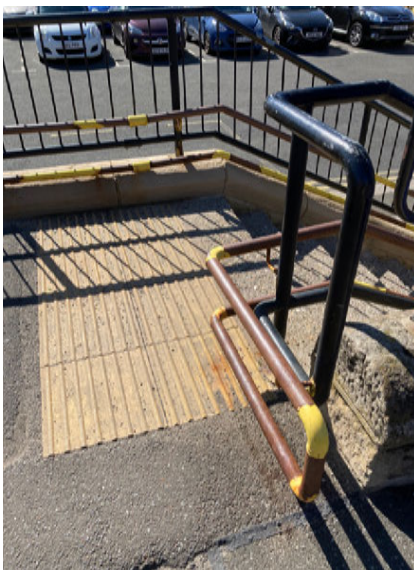
4. Handrails and guarding should be subject to a rolling programme of repainting. Particularly bad is the corroded state of handrails etc on the ramp from the car park and bus stop at Prudhoe up to platform 2.

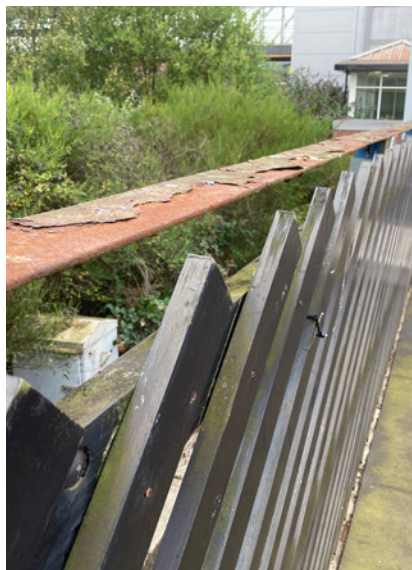
3. The paint/stain to the timber fences is in reasonable condition, but again, a rolling programme of painting should be instigated. The support steelwork to the fences at the Metrocentre is corroding badly and is distorted in places. This should be cleaned down and repainted.

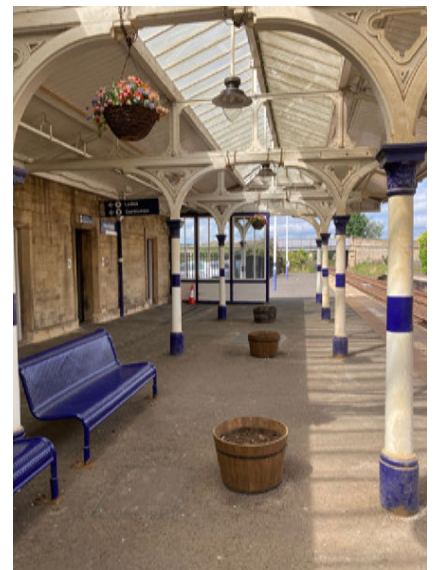
5. The metalwork and timber at Hexham is looking very down at heel and should be repainted as befits this flagship station.
6. The rooflights at Hexham and Corbridge are in desperate need of cleaning. It would dramatically improve the appearance and ambience of both stations by raising the levels of natural lighting on the platforms.
